California City Reduces Lift Station Maintenance with MICROBE-LIFT® Technology

Location: Kerman, CA, USA

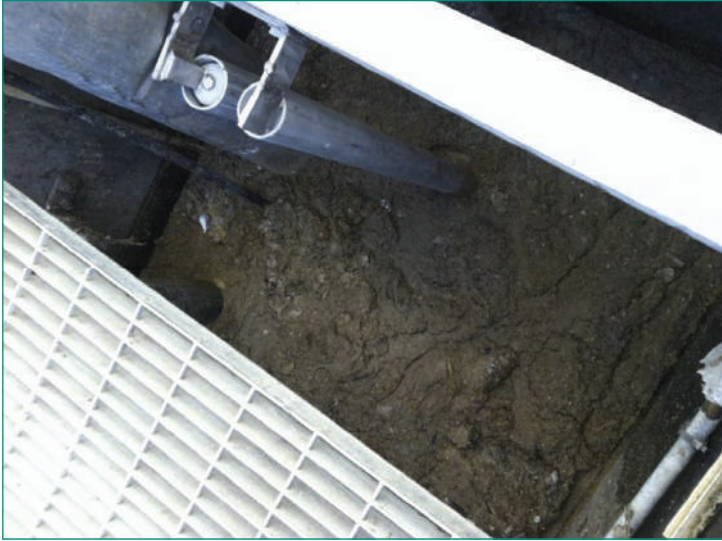
Results Achieved: The results of treatment with MICROBE-LIFT®/IND were dramatic as depicted by the pictures below. Before treatment on February 8, 2012 the lift station pictured below was heavily impacted with grease and scum.

Fig. 1: With the grate open, a 2 - 3 foot grease layer is evident prior to treatment.

Initially both the wastewater and collection wells were each dosed once with 3 gallons of MICROBE-LIFT®/IND. Thereafter 1 gallon was added to the collection pit daily for four days. Starting on the fifth day, the system was maintained on a dosage of 1/2 gallon per week.

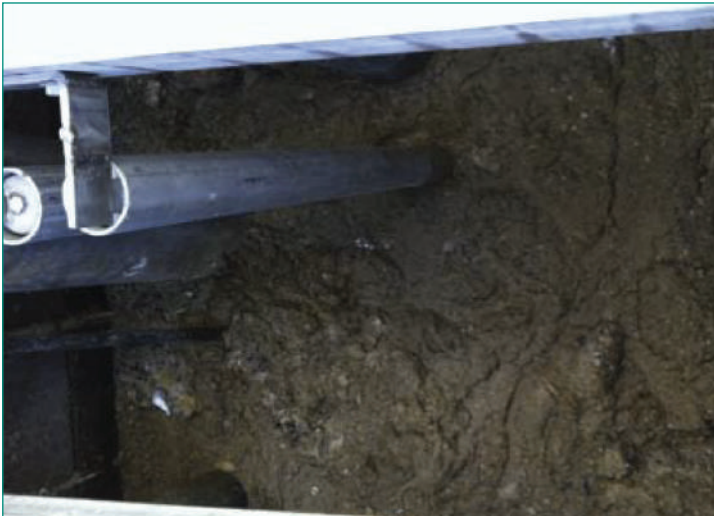
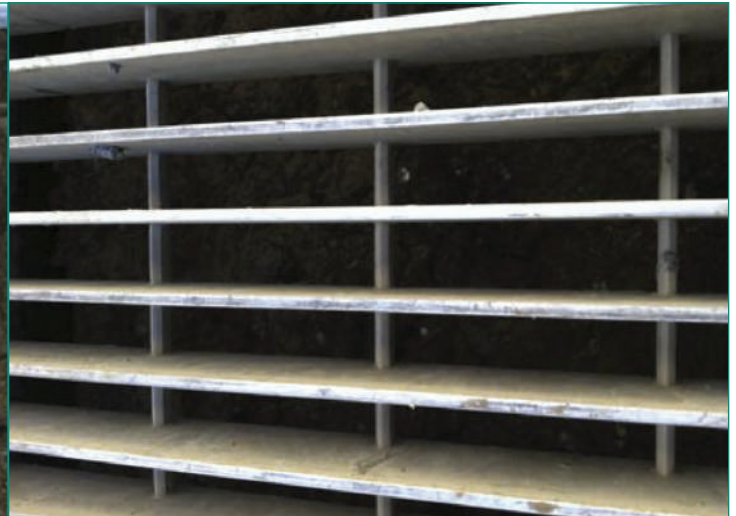
Fig. 2 & 3: These pictures show a side view with gate open and a top view with gate closed.

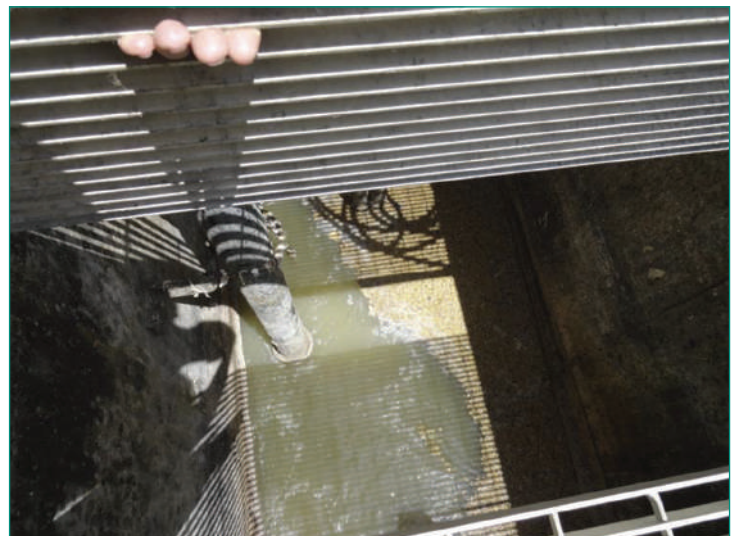
Fig. 4: May 18, 2012 after three months of treatment, the grease cap has not returned.

After three months with only the maintenance dose of ½ gallon per day being applied, the grease layer has not returned.

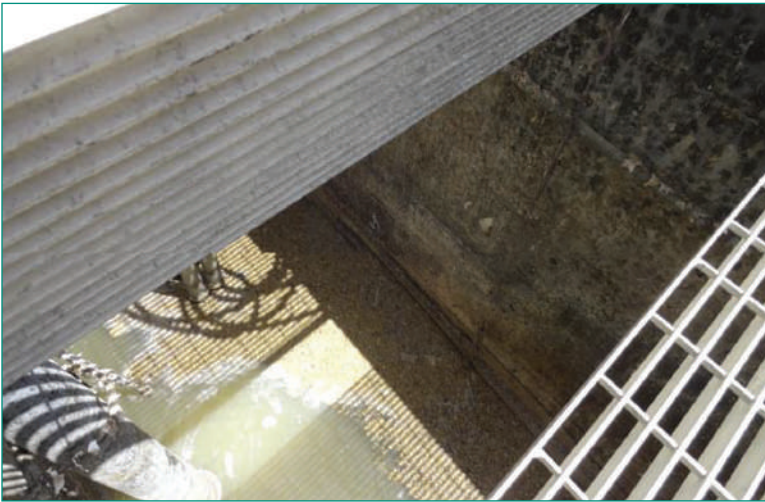
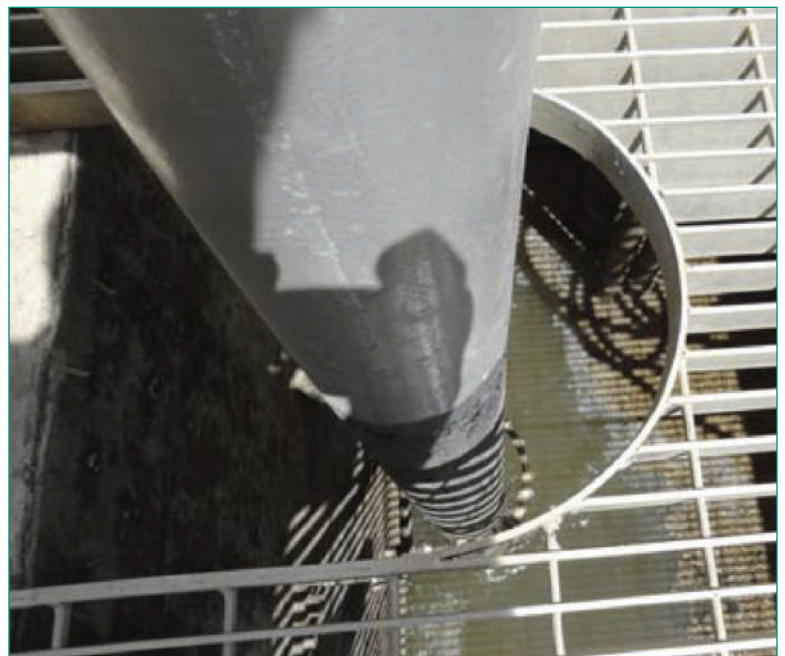
Fig. 5 & 6 These pictures further demonstrate the lack of new buildup of the grease cap when seen from a side view and through the grate from the top.
