## **MICROBE-LIFT® Technology Eliminates the Need for Capital Investment at a Rendering Plant in Guatemala**

**Location:** ARECA’s Frisa Rendering Plant, Palin, Guatemala

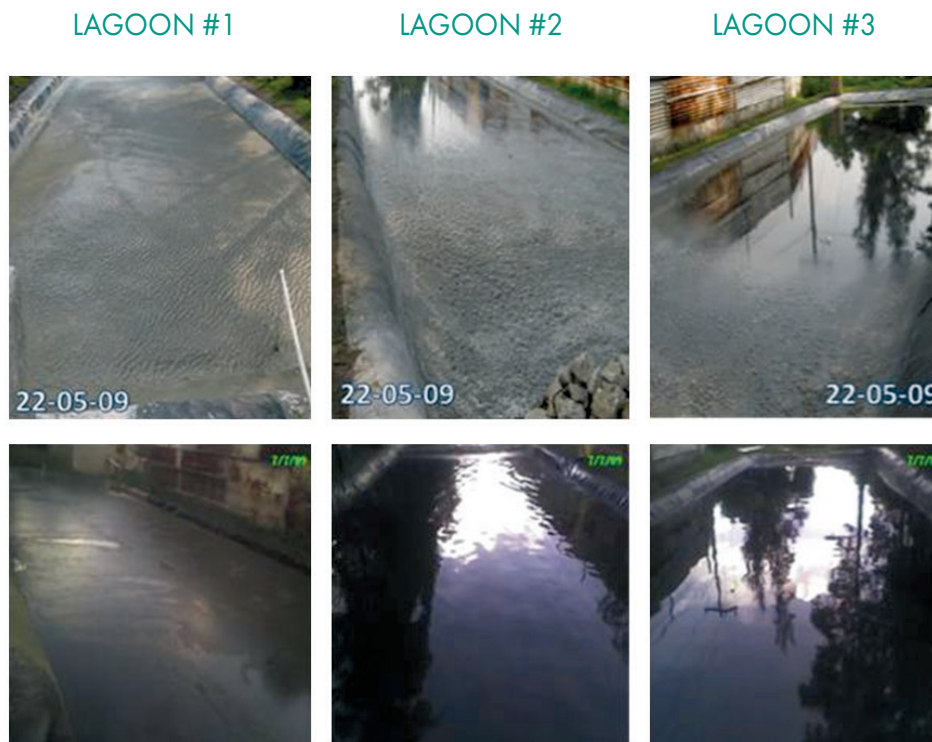
**Fig. 1:** These pictures taken on 5/22/09 (above) and 7/1/09 (below) show the condition of the three lagoons after treatment compared to during treatment. Note the condition of the lagoons improve from the first to the third lagoon in the series.

**Ecological Laboratories, Inc.** also recommended that by constructing a simple block wall one meter high to increase the lagoon depths, they could increase the retention time to provide an anticipated effluent discharge below 100 mg/l COD and 50 mg/l BOD.
